# PRAIRIE Water News

***Vol. 17 No. 2  
Fall 2007***

## Simple Well Depth Gauge for Everyone

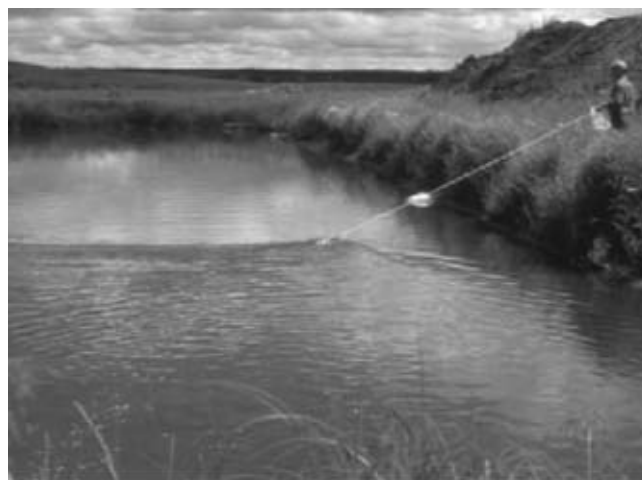
*Applying Copper Sulphate*

Whichever product you choose to use, it is important to apply it in accordance with the product labelling. The labelling will specify restrictions both to protect the environment, and to ensure that the treated water is safe for its intended use (irrigation, livestock watering, domestic water, drinking water).

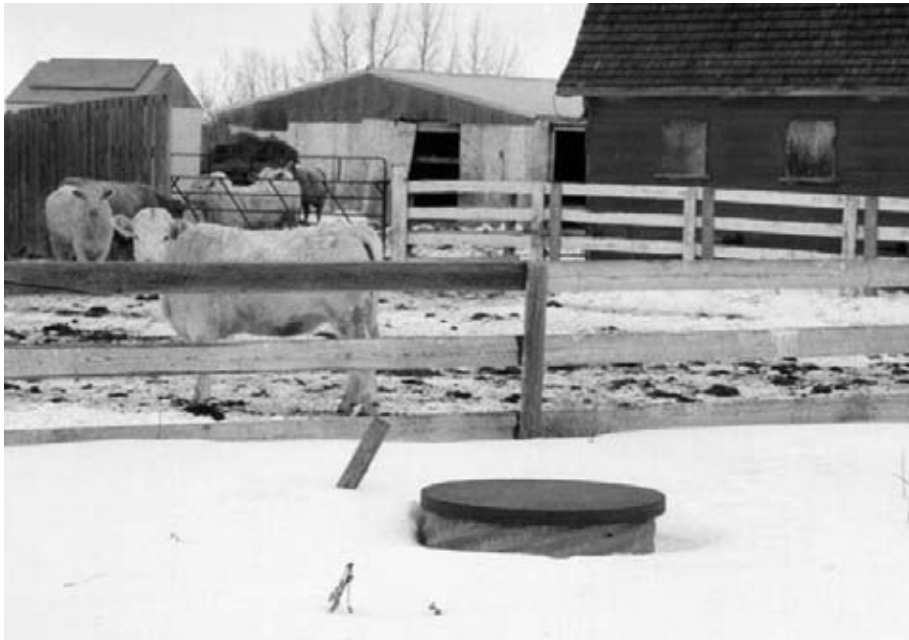
*Well in Corral*

wells are associated with either a corral, are in close proximity to land receiving nitrogen fertilizer applications, or are within 100 meters of a septic field.

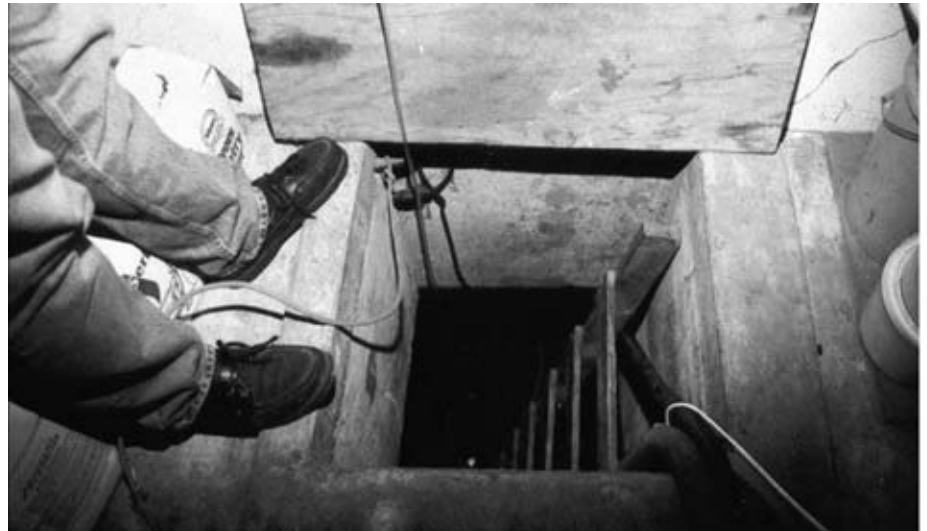
Well Pit

Subsequent monitoring of the Staudinger's well indicated that the well was safe to enter 89.9% of the time but 10.1% of the time the air quality would not support life. The culprit in this case is nitrogen gas being released from the well water during low pressure weather cycles. The nitrogen displaced the oxygen needed for life and anyone entering the pit could become overcome by

the lack of oxygen. Most waters contain dissolved nitrogen and carbon dioxide which can be released at various times depending on the concentrations. In some cases, wells like the Staudinger's well are known to breath large volumes of gas during certain conditions which can prove fatal to humans in a confined space such as a well pit.

In 1993, legislation was passed in Alberta to prohibit the use of well pits. The legislation acknowledges the extremely high risk that well pits pose to individuals and to groundwater contamination. In rural areas well pits were first used to provide a convenient frost-free location for the landowner's water system. Over the years thousands of these below ground well pits have become flooded resulting in contamination flowing into the top of the well.

For anyone who has an existing well pit, it is highly recommended to extend the well casing, install a

proper frost free connection called a pitless adaptor, and fill in the pit

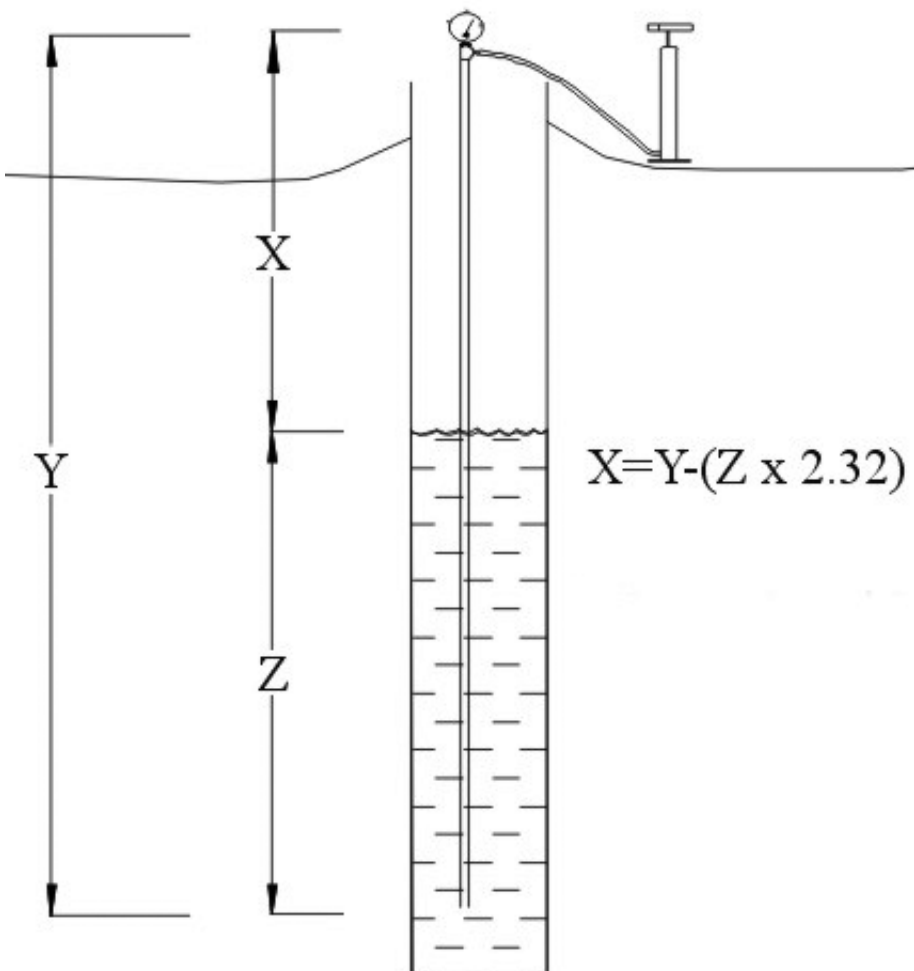
Water Level Calculation

altitude gauge, a tire valve and a bicycle tire pump. The tubing is run down inside the well (usually attached to the drop pipe) to a depth that will always be under water. You must know the exact distance from the middle of the gauge to the tip of the copper tubing. The pressure/altitude gauge and a tire valve are attached to the top of the copper tubing. Whenever a water level is needed, you simply attach the bicycle pump to the tire valve and pump air into the pipe until the pressure/altitude gauge reaches the maximum

reading. This reading is the point at which further supply of air will not increase the reading to any higher value. With the reading on the pressure gauge, the water level can easily be calculated.

When air is added to the copper tubing, the pressure created will displace the water inside the tube by forcing it out the bottom. Since one pound of pressure will displace 2.31 feet of water from the tube, the exact depth of water that had to be displaced can be calculated. To convert the reading in PSI to feet of

Example: Assume the tubing is 100 feet long from the center of the gauge to the bottom end of the pipe and that the highest reading of the gauge is 15 PSI.

(See Diagram)

Let X = Depth to Water Level  
(in feet) Unknown

Y = Known Length of Air Line  
(in feet)

Z = Air Pressure inside Copper  
Tubing. (From Gauge)  
(Multiply PSI by 2.31 to  
convert to feet)

$$X = Y - (Z \times 2.31)$$

In this case, the water level would be 65.4 feet below the center of the gauge.

For ease of reading and increased accuracy, it is important to select a large-faced pressure gauge with relatively low maximum reading. Unless the depth of water over the end of the pipe is greater than 70 feet, a 3" diameter 0-30 PSI gauge is ideal. A gauge of this type is much easier to read than a 1 1/2" diameter 0-100 PSI gauge normally found on most pumps.

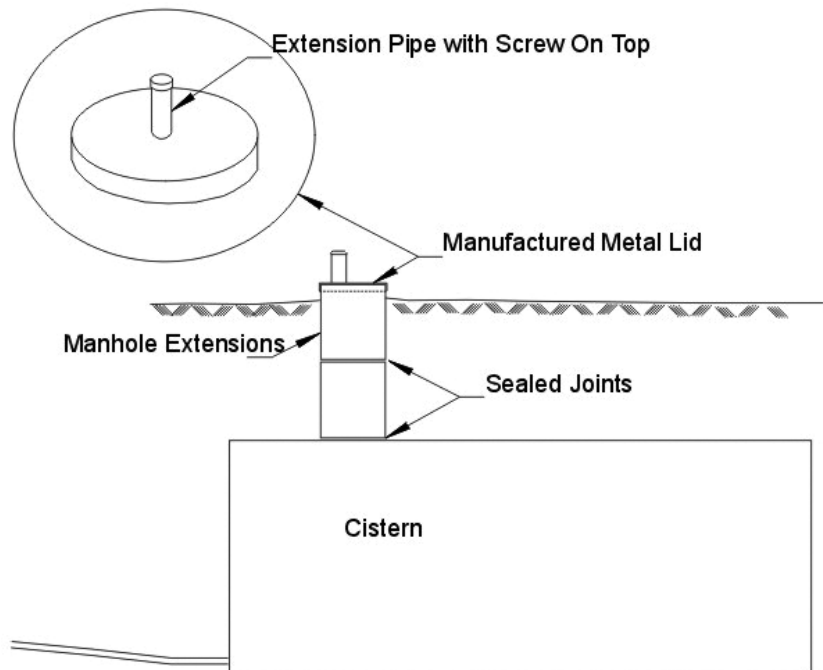
Areas to be Sealed

Many of these buried cisterns are constructed of either concrete or fiberglass. While the main body of the tank is made to hold water and is therefore water tight and not open to contamination from the surrounding ground, the extension or manhole providing access is not. As example, when a concrete tank is installed with a minimum of two feet of earthen cover, the joints are often not sealed properly or not sealed at all. In many cases, this manhole extension is back filled with granular material to prevent settling. Unfortunately, any rains or spillage of water on the area surrounding the access hole will simply flow through the granular material, through the open joints and into the cistern carrying with it numerous contaminants from the soil. In other cases, the person hauling

water will fill the cistern too full filling up the manhole extension as well as the cistern. This excess water will flow out through the joints into the surrounding soil and then flow back again as soon as some water is taken from the cistern. This often results in murky or dirty water for a short time after the cistern has been filled. Many residents will mistakenly assume the water is simply riled up during the filling process and there is no cause for concern. Any flow of water from the outside to the inside of the cistern is a concern as it will always bring in a number of contaminants as it flows back into the cistern.

A simple way of checking to see if the joint in the manhole are properly sealed would be to use garden hose and pour water on the ground surrounding the top of the manhole.

If seepage coming into the cistern around the manhole is observed, steps should be taken to properly seal this area of concern. For proper sealing, the area around the manhole would have to be excavated, the extensions removed, cleaned, caulked with a high grad of caulking and the extensions reinstalled.
